National Weather Service Pocatello

Storm Damage Survey: Conducted June 23, 2011

Location: Approximately 1.5 miles southwest of Moreland, Bingham County

Approximate time of damage: Wednesday, June 22 6:50-7:00 pm.

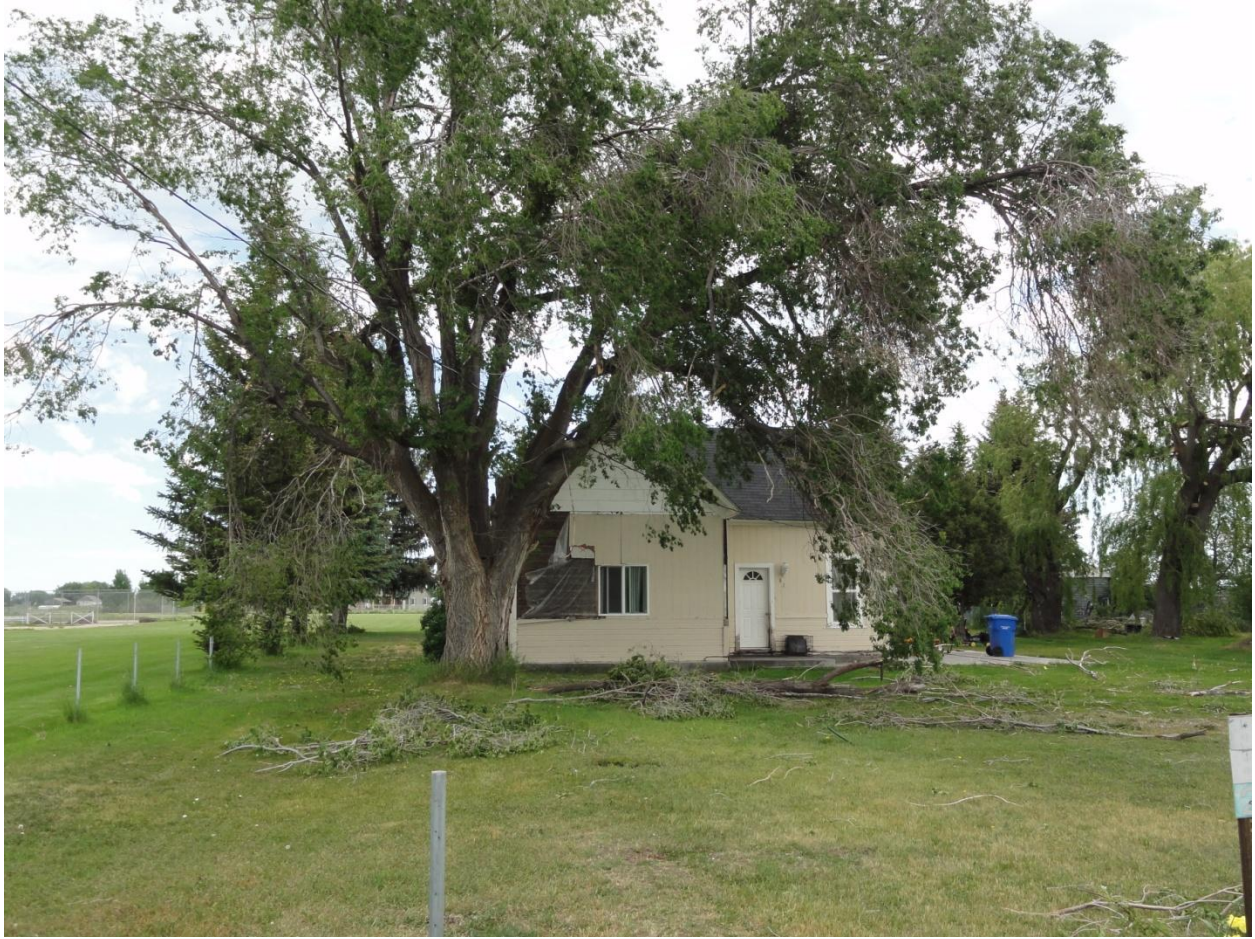
Property #1: Damage consisted of wood siding removed from a portion of the front of the home. Trees in the front yard were damaged with a large tree branch broken off and suspended in the tree with

numerous smaller branches scattered about the front yard. Power was lost at this home. A large round trampoline in the backyard of this home was not disturbed.

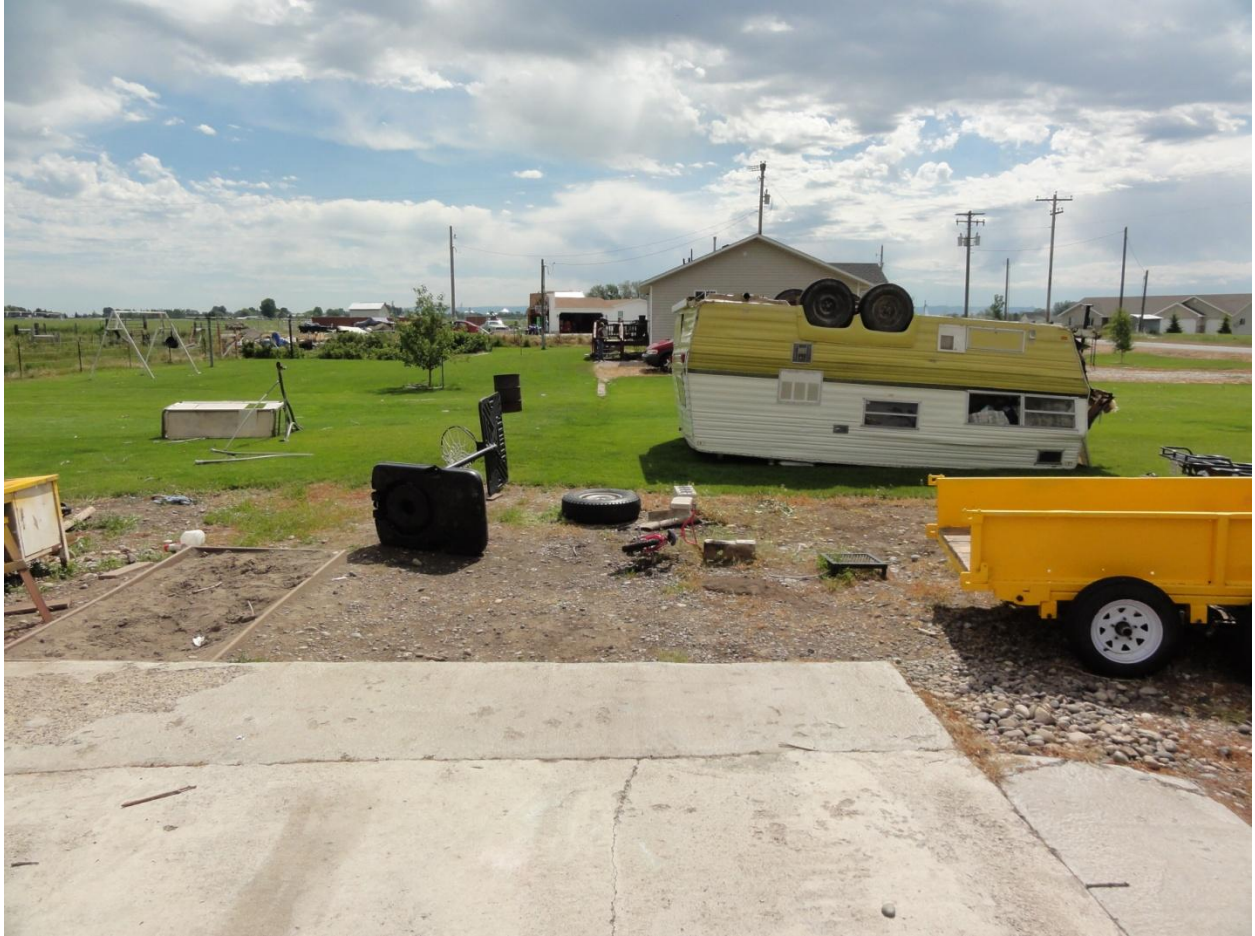
Property #2: Damage consisted of small branches scattered about the yard. A couple of medium sized trees were leaning over. A camper trailer was flipped over.

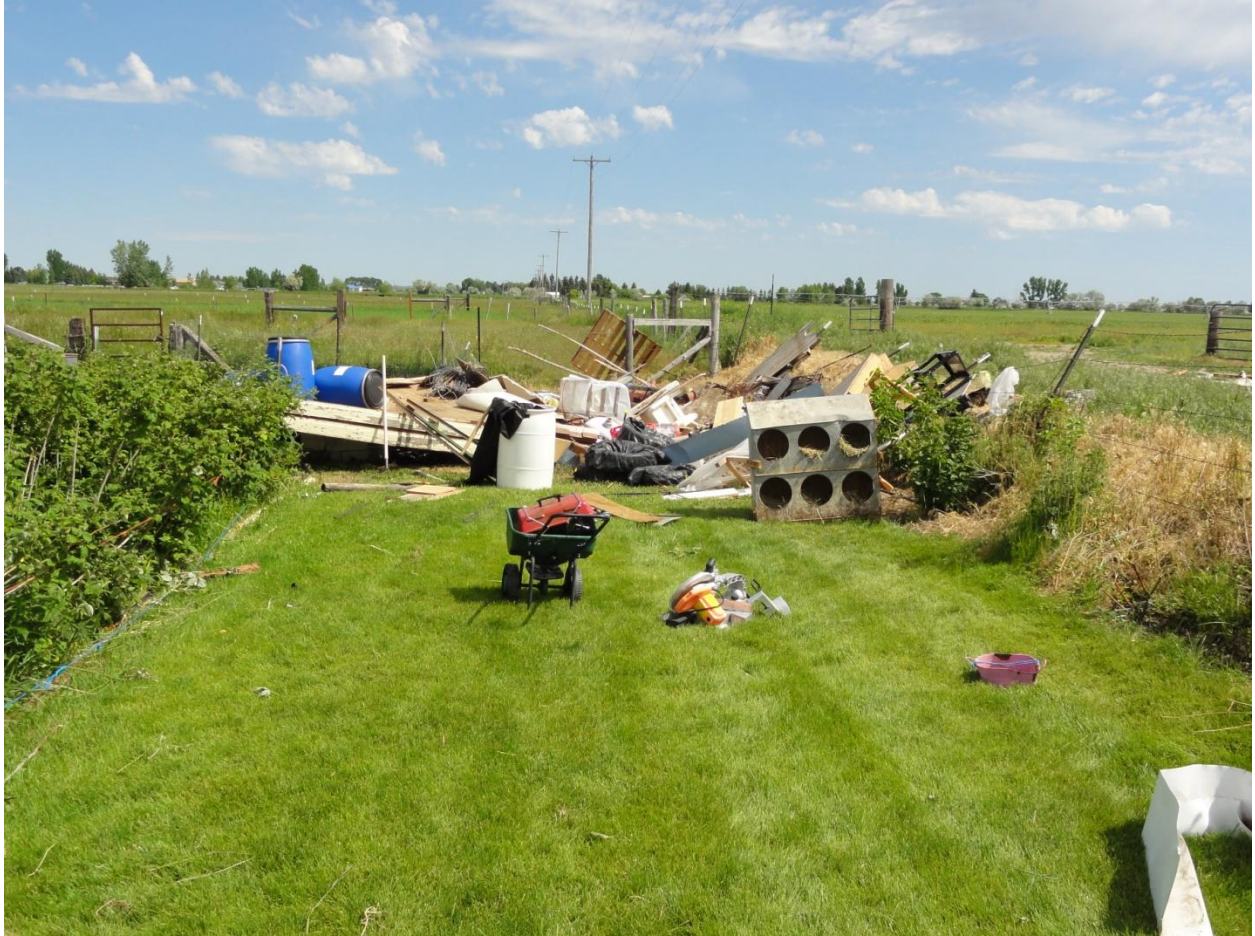
Property #3: A wooden shed was destroyed with small debris scattered about the backyard. The shed was resting unsecured on a concrete block foundation. The floor of the shed did not move too far as there were several large barrels of water sitting on it. Walls and contents of the shed were laying adjacent to the foundation and scattered over several yards east of the original structure.

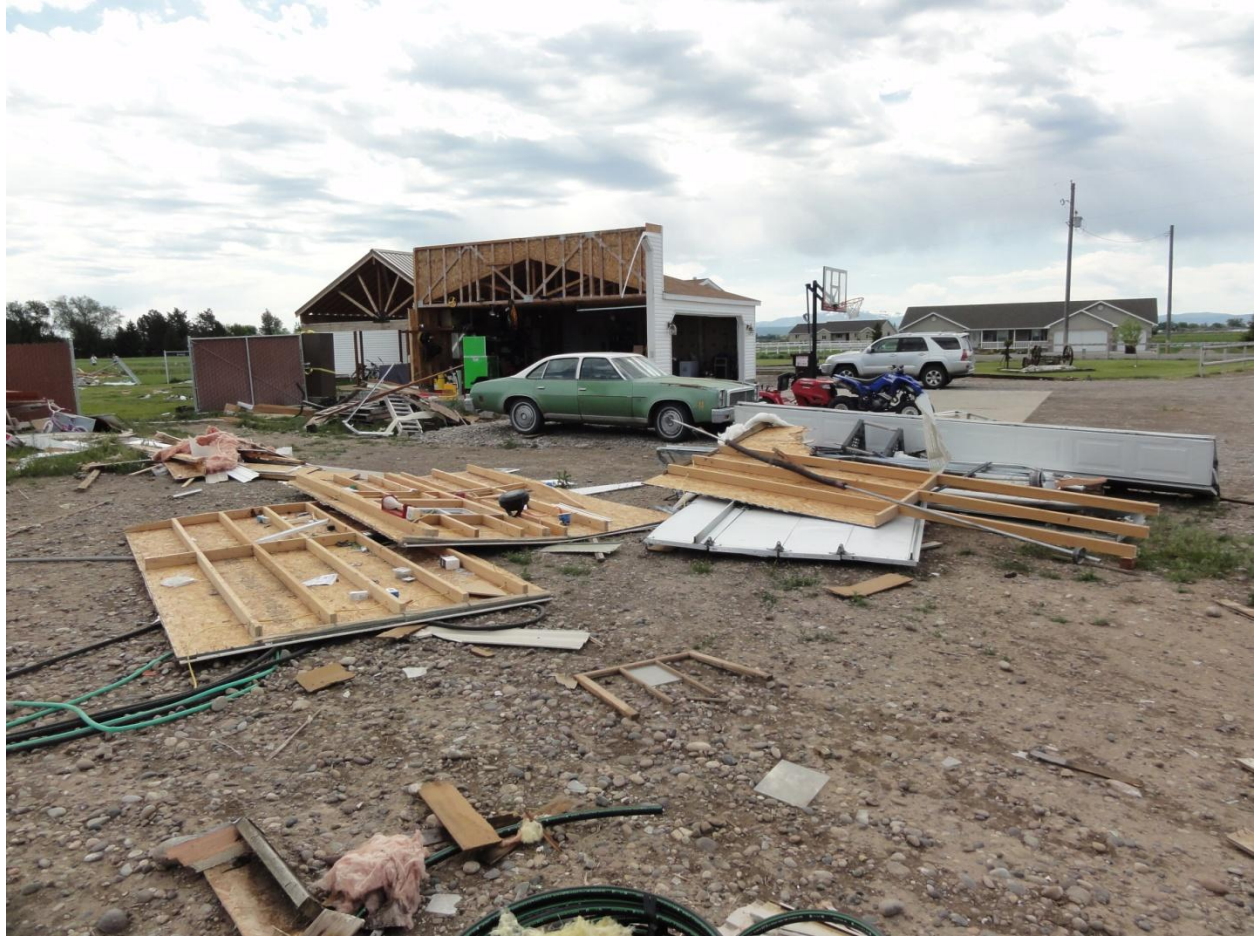
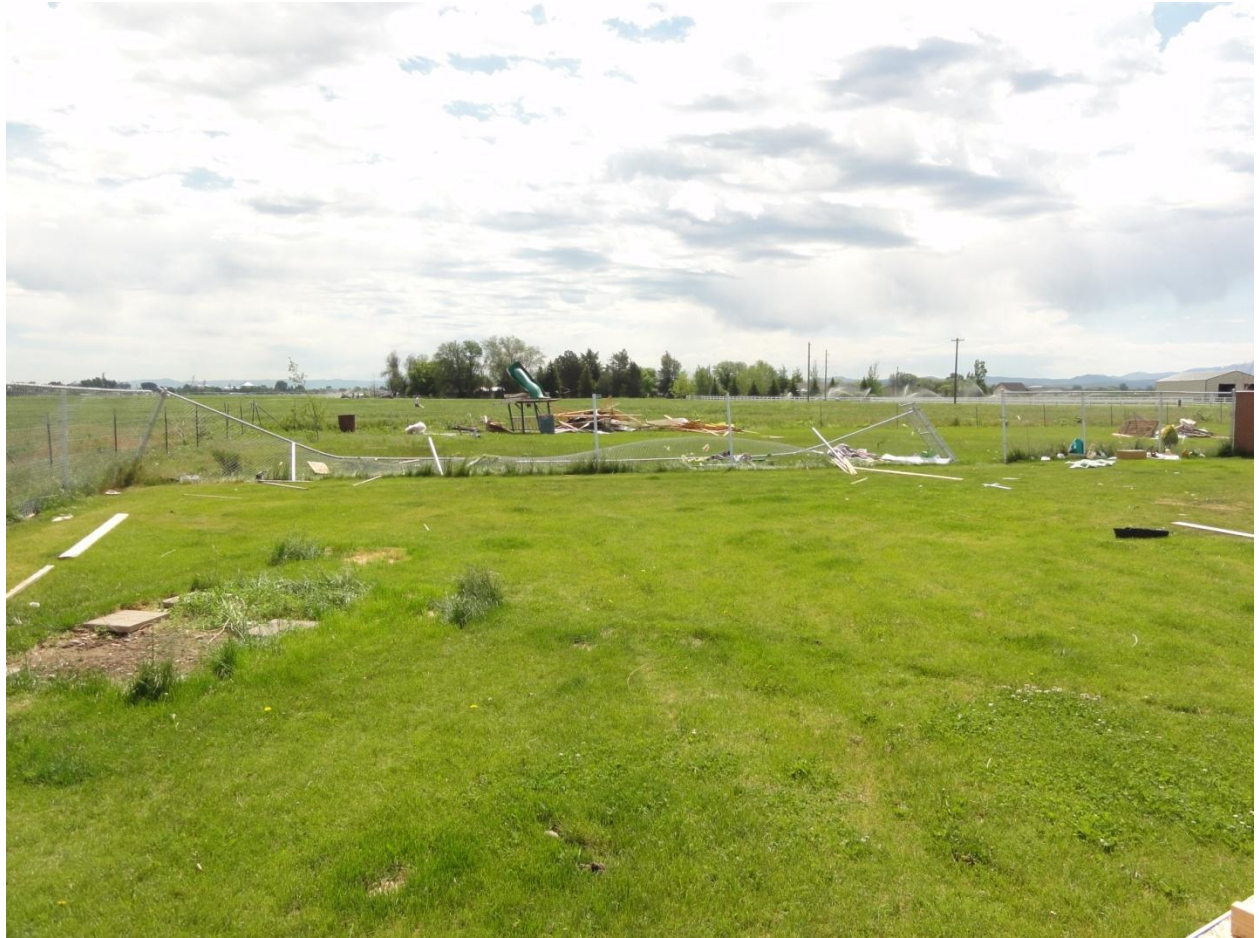
Property #4: A garage attached to the back side of the home was destroyed. The foundation of the garage was of poured concrete with anchor bolts securing the two by four constructed walls to it. The garage walls were pulled from the two by fours bolted to the foundation. Debris from the garage was scattered several yards to the north and east and into an adjacent crop field. A barbed wire fence was taken down by the debris.
